Subj: Suspected bombing of M/V GRANWOOD; investigation of *J. J. R.*

FROM: ENS. L. J. GALLO, 43519, 1
TO: COMMANDER, EIGHTH CG DISTRICT (OLE)
VIA: COMMANDING OFFICER, GROUP MOBILE
SUBJ: SUSPECTED BOMBING OF M/V GRANWOOD

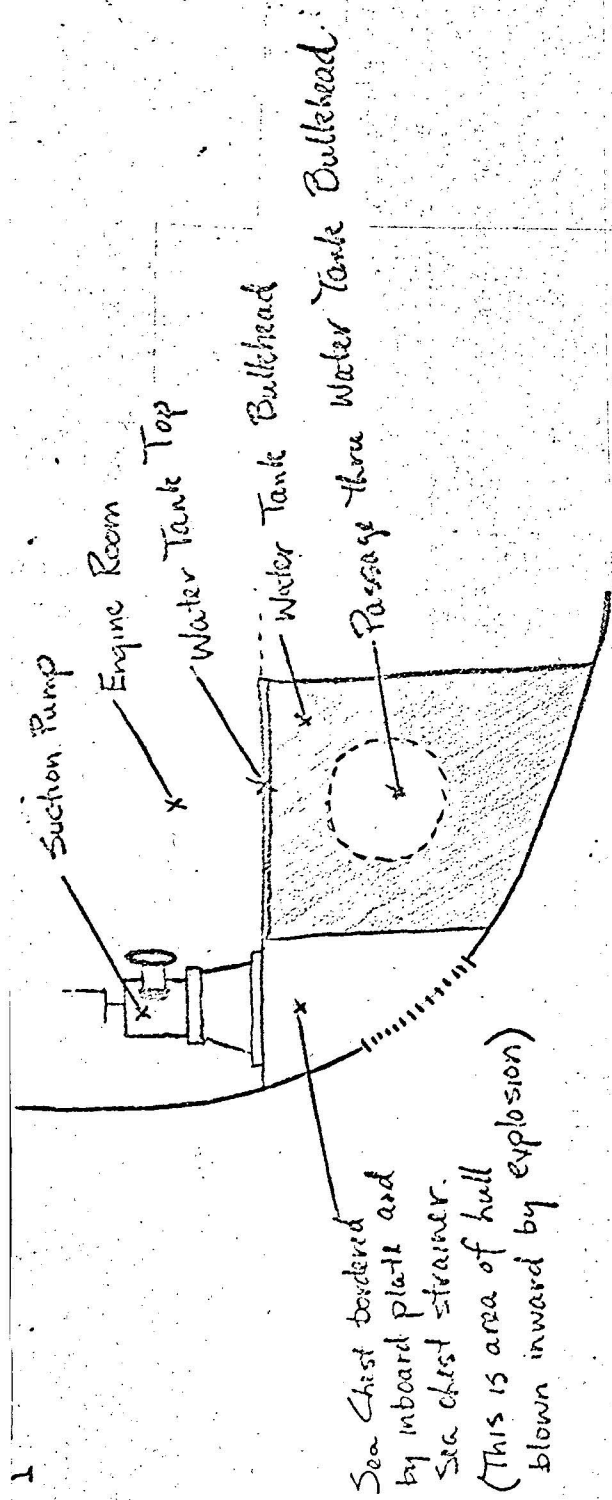
Enclosure 1

- (y) represents the plate which was curled back by the explosive force. (z) represents forward bulkhead of the sea chest. Note how this bulkhead has been twisted apart by the blast.
- (4) Shows plate curled up at the rim of the sea chest aperture. Picture is inboard view of outboard side of the sea chest.
- (5) Picture shows member of investigating team descending thru hatch into forward half of water tank 2 frames forward of the sea chest.
- (6) Picture taken looking aft in engine room. Note how frame is buckled at (x). Hatch leading to water tank is in the lower left hand corner of the picture.
- (7) Picture is taken looking outboard toward hull. (x) marks the entrance to the water tank.
- (8)-(11) Pictures show starboard side of M/V GRANWOOD from aspects beginning aft and proceeding forward. Hole in hull occurred between FRAMES 31 and 32 FROM AFT just under water tank top.

A. CROSS SECTION - AFTER STARDOWN QUARTER LOOKING AFT
(BETWEEN FRAMES 31 & 32 FROM AFT)

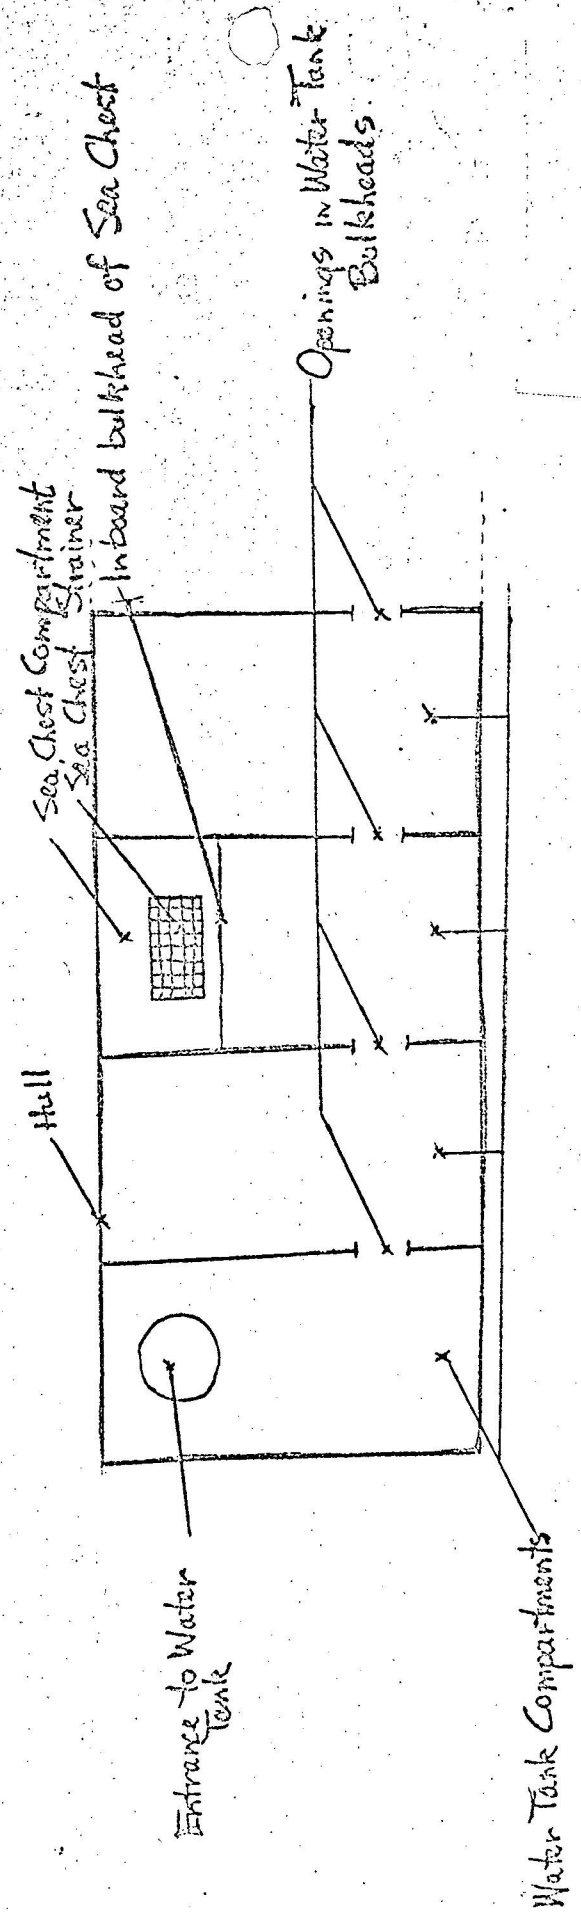
B. TOP VIEW - LOOKING THRU WATER TANK TOP DOWN INTO WATER TANK
